Safety Bulletin

SB-Y10-02 Page 1 of 2

Pressure Relief Assembly /
Inspection and Service.

Chart Beverage Systems
CO₂ storage vessels
Carbo "Mite" 200, "Charger" 300,
and "Mizer" 450.

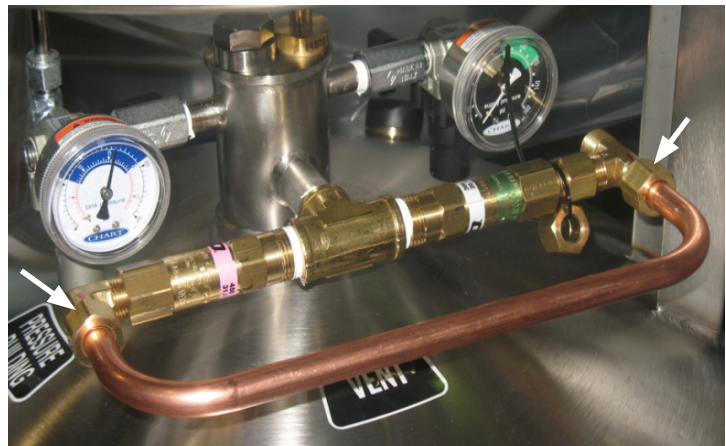
Pressure relief vent tube assembly on CO₂ storage vessel.
(Arrows indicate compression fitting connection.)

Chart has discovered a potential service and safety issue with the vent tube of the pressure relief assembly installed on Chart Beverage CO₂ storage vessels manufactured between May 1, 2006 and January 1, 2007. The compression connections holding the vent tube may have not been properly tightened on some vessels. **If the tubing is not completely secure, and if one or both of the relief valves in the vent circuit activate, sudden pressurization may cause the vent tube to dislodge from its connections and injure a bystander.**

The vent tube component of the pressure relief assembly on Chart Beverage Systems CO₂ storage vessels is attached between a brass tee and elbow as seen in the picture above. It is secured at each end by tightening a 3/8" brass nut on the compression fitting. **CO₂ storage vessels that were manufactured within the period of May 1, 2006 to January 1, 2007 must be inspected immediately for tight vent tube connections and corrected, if necessary, to avoid malfunction or injury.** Follow the inspection procedure and corrective action described on page 2 of this bulletin to ensure that vent tubes are properly tightened. If you have concerns or questions relative to a vent tube pressure relief assembly, please contact your Chart Technical Service Representative at 800-253-1769 or 952-758-4400.

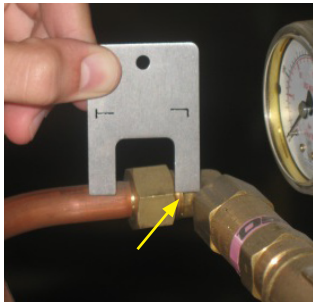
Picture 3 (Proper Elbow Spacing)

- 4) The spacing gauge is a “NO-GO” gauge; if the nuts are tightened properly the gauge **cannot** be inserted between the nut and the valve body as seen in pictures 3 and 4.
