# EMISSIONGUARD™ TR<sup>2</sup> Rings Give 3.5 years Running Life in Lubricated High Pressure Hydrogen Application

## The Challenge

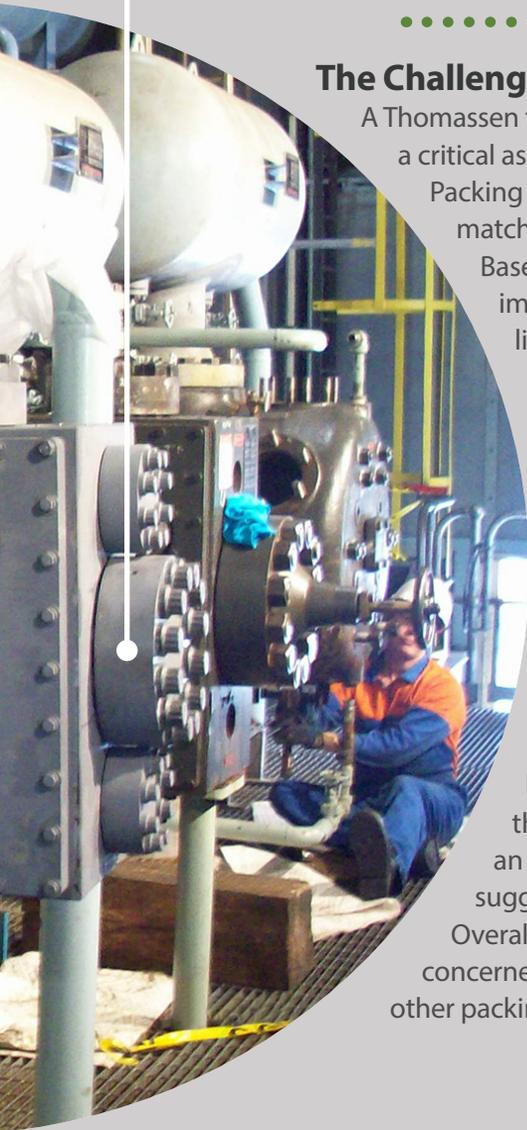
After four years of continuous operation, overall ring wear with EMISSIONGUARD™ TR<sup>2</sup> was very low. However, inspections revealed ring deformation and breakage, along with excessive oil accumulation within the packing case cups.

A consistent wear/failure pattern was identified in the first EMISSIONGUARD™ TR<sup>2</sup> sealing ring group positioned in the cup immediately after the pressure breaker, affecting almost all 12 packing cases. The deformation and breakage were most pronounced in the third stage packing cases operating at 220 bar.

The condition is consistent with hydraulic pulsing of the packing rings caused by excessive oil accumulation in the packing area, which increases loading on both the rings and the garter springs. Notably, the tangent gaps of the EMISSIONGUARD™ TR<sup>2</sup> rings remained close to their original dimensions—an extremely positive outcome—yet garter spring failures still occurred, suggesting an additional contributing failure mechanism.

The most likely cause is hydraulic constraint resulting from liquid accumulation in the packing area. The following actions are recommended:

- **Confirm lubrication rate** against field settings and actual consumption data.
- **Verify lubrication distribution** by inspecting check valves, filters, and lubrication lines for restrictions or blockages.
- **Assess liquid carryover from the process side** and confirm drains and level control are functioning correctly.
- **Review operating practices** to minimize extended unloaded operation where possible and to prevent excess oil during reloading.
- **Verify inlet water temperature** and maintain it at least **5°C above the gas inlet temperature**, in accordance with **API 618**.

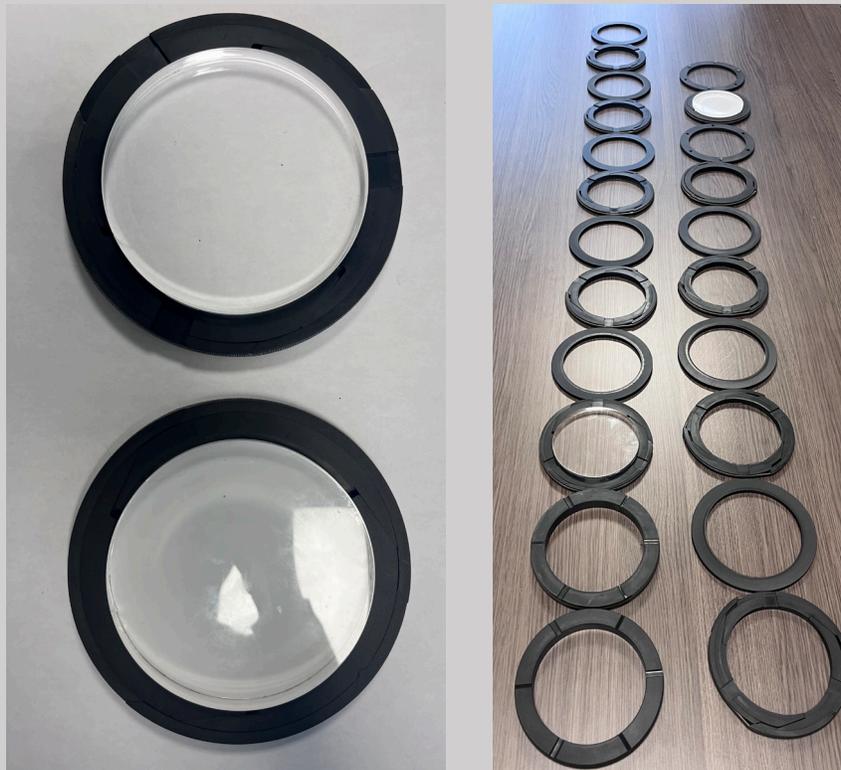
Based on four years of operation, the observed condition was assessed as consistent with expected wear and failure behaviour for the application. The customer was very satisfied with the overall results. The packing case ring set was replaced with a new set of **EMISSIONGUARD™ TR<sup>2</sup>** rings, restoring the compressor to service. CPI believes that implementation of the above recommendations could enable up to four years of operation, delivering an approximate 33% increase in service life in this demanding application. The customer confirmed satisfaction with the level of technical support provided, and we are pleased to have contributed to the measurable gains in running life achieved to date.
