Restoring Compressor Reliability Through Rapid Cylinder Rehabilitation in Ivory Coast

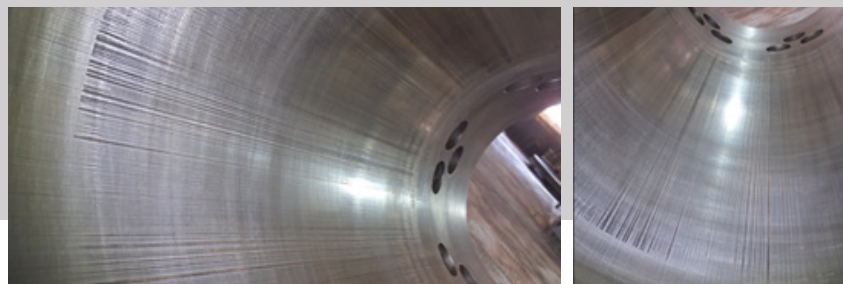
In December 2025, a lubrication failure resulted in rapid degradation of the Packings and Piston/Rider Rings. This failure escalated quickly, causing direct contact between the piston and the first stage liner. The liner suffered significant damage, including deep scratches and severe marking across the active surface area, requiring immediate technical intervention.

Given the excessively long lead times for supplying a new cylinder liner (shirt), the customer requested an alternative solution to minimise downtime. CPI responded by proposing and executing on site re machining of the existing liner, complemented by the supply of two new sets of Piston/Rider Rings adapted to the restored cylinder diameter.

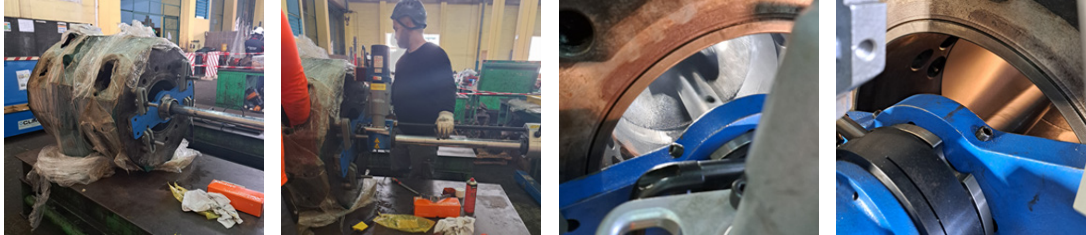
The re machining activities were performed by CPI France at our customer's premises, in Ivory Coast

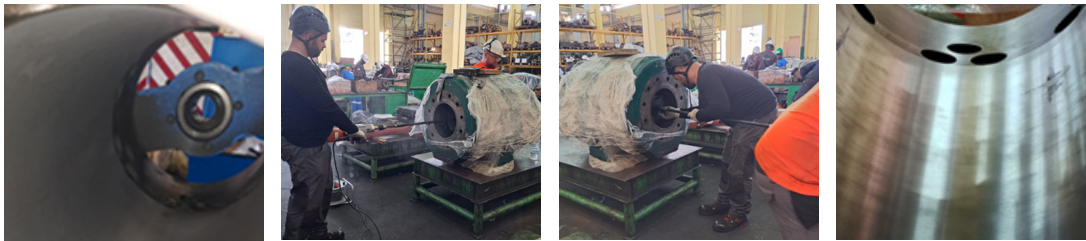
Machining operations eliminated deep scoring and surface defects on the liner's active area, restoring its functional integrity.

Final honing operations brought the liner surface finish into full compliance with CPI's specified roughness requirements for this type of application.
