Smart Layer[®] Saves the Day (Twice!)

Two Case Studies of Smart Layer in Action and a Recent Design Improvement

Presented at GPA Midstream Technical Conference
April 10, 2024

Adam McNeilly
Chart Industries
La Crosse, WI, United States

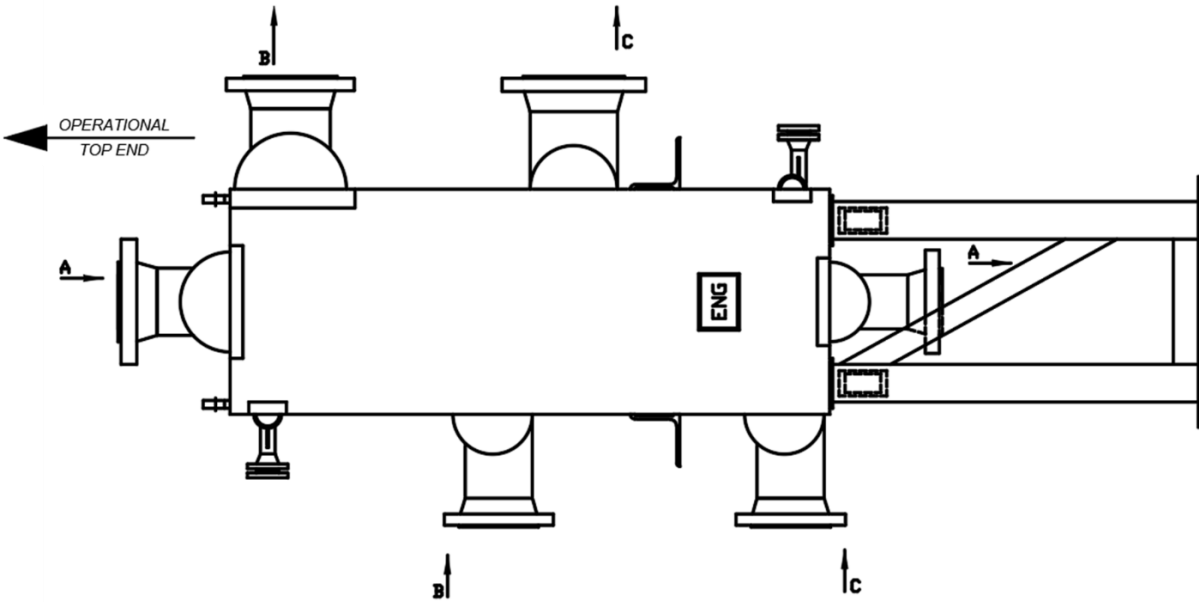
Figure 4: Story A BAHX diagram

Success story A concerns a demethanizer tower side reboiler designed with Smart Layer technology and commissioned in late 2019. The plant owners indicate that they had previous experience with parting sheets and cap sheets cracking at this plant requiring numerous repairs. The Smart Layer was given an initial charge pressure of ~200 psi. Within a year of commissioning the new reboiler, the first Smart Layer indication occurred.

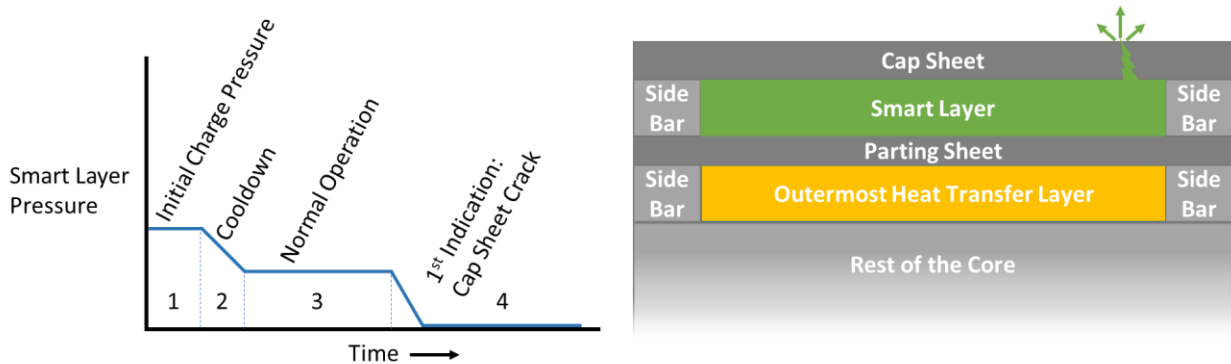
The first Smart Layer fatigue indication occurred in the middle of 2020 and manifested as a loss of Smart Layer charge pressure. It was discovered that both cap sheets had formed cracks midway up the length of the core, near the inside edge of the bar column. No loss of process fluid containment occurred, and the unit was able to continue to safely operate for several months until repairs were made. The BAHX was repaired by welding the cap sheet cracks closed. The Smart Layer was recharged and the unit was placed back into service with intact Smart Layer functionality in the Repaired condition.

Figure 5: Story A – 1st Indication

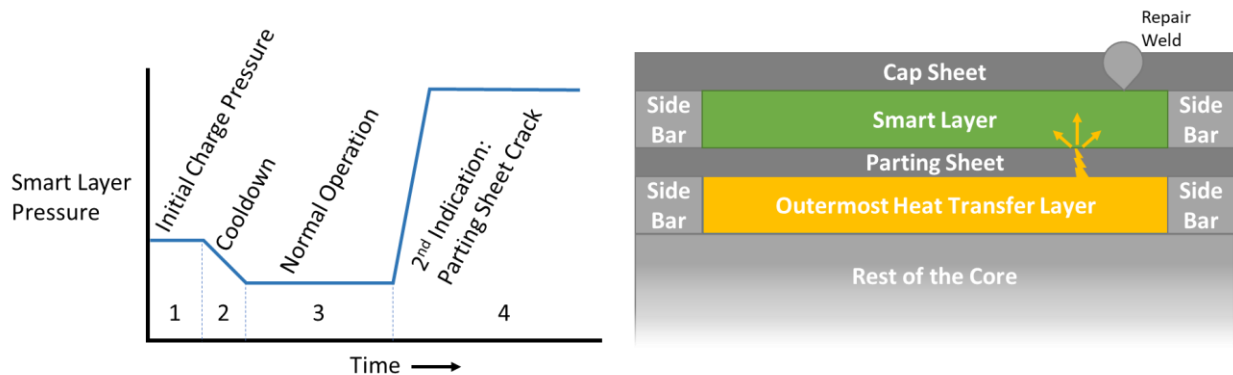
After the BAHX was placed back into service, the unit was able to operate normally until the second Smart Layer indication occurred, this time as a rise in Smart Layer pressure. The outside parting sheets between the outermost active stream and the Smart Layer had cracked, allowing

process fluid to leak into the Smart Layer. No loss of process fluid containment occurred, and the unit was again able to continue to safely operate for several months until repairs were conducted.

Figure 6: Story A – 2nd Indication

The outermost heat exchange pitches were isolated from their process streams and connected to the Smart Layer, effectively adding them to the Smart Layer inactive layers. This allowed the Smart Layer to again be recharged and continue to operate after the core was returned to service in the Repaired condition.

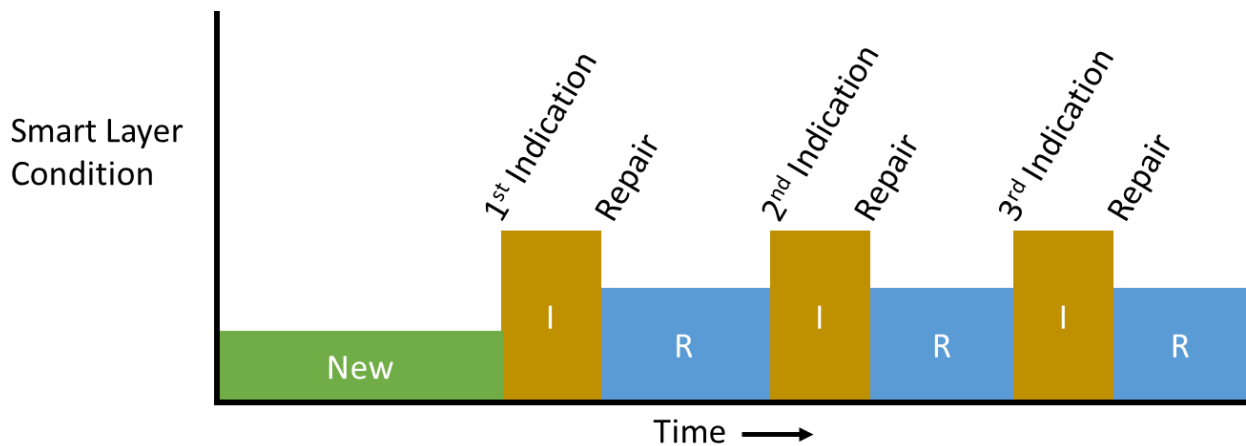
After another period of normal operation, additional leaks in the cap sheet occurred at the same locations where the original cracks had appeared. This caused the Smart Layer pressure to drop and resulted in the third fatigue indication. Again, no loss of containment happened.

Figure 7: Story A Smart Layer condition progression

Chart performed an analysis of the plant operating data, and although the unit was not fully instrumented, some key insights were identified. Specifically, reboilers are known to be sensitive to outlet pressure variations, and differential pressure measurements can identify when reboilers have entered an unstable flow regime. Although this instrumentation was not installed for this unit, there were indications of unstable flow occurring.

Operators revealed the unit was regularly operated at 50% of design duty. Turndowns have been known to cause unstable boiling and premature failure caused by thermal fatigue in similar reboilers, as identified by the GPA in their technical bulletin GPA-TB-001 and described by Vallee et. al. in their 2019 paper “Best Practices for Design and Operation of Reboilers with Plate-Fin BAHXs.”

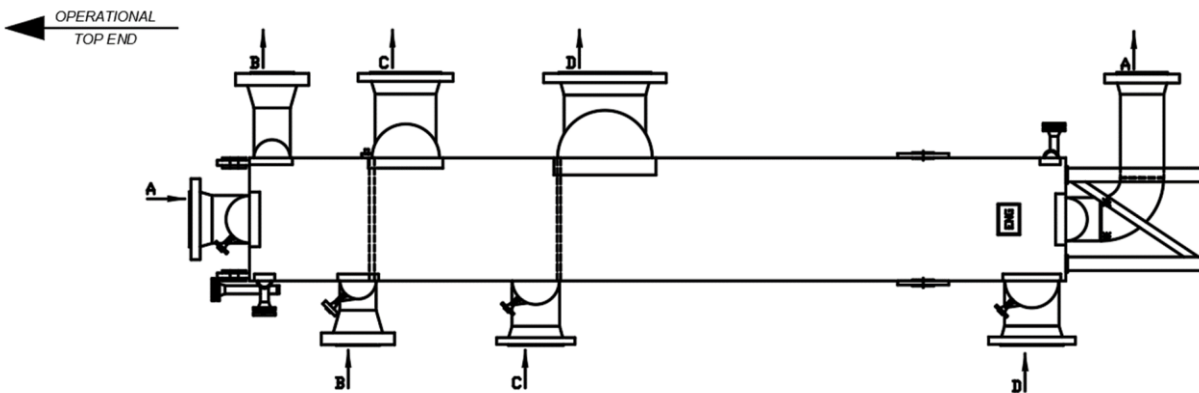
Figure 8: Story B BAHX diagram

Success story B involves a replacement side-bottom reboiler designed with Smart Layer that was installed in 2020. The outgoing BAHX was a two-module¹ design that had leaked at the inter-module weld joint.

The first indication occurred in later 2021 when the Smart Layer pressure rose. The plant continued to safely operate until a scheduled shutdown when an inspection revealed a cross-pass leak between the outermost active layer and the Smart Layer. The outermost heat exchange pitches were isolated from their process streams and connected to the Smart Layer. The unit was returned to service in the Repaired condition with Smart Layer functionality intact.

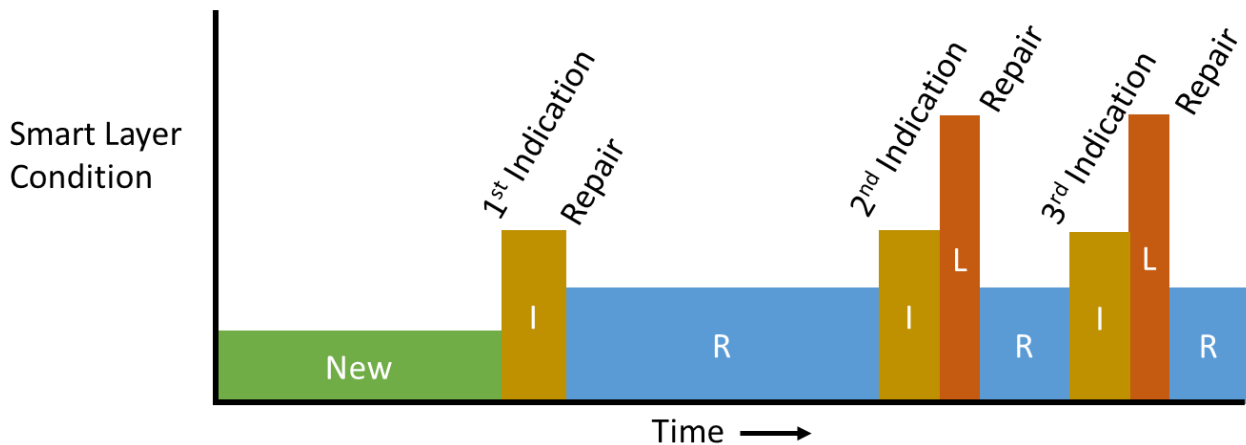
After the repair, the unit operated normally for a year until another Smart Layer indication occurred in late 2022. The inspection report states that a cross-pass leak into the Smart Layer and an external leak from the Smart Layer were found. If found separately, neither of these leaks would cause a loss of containment, but when they are encountered together, they can lead to an external leak of process fluid. Although specific details were not available, it is likely that after the first indication and repair, a second indication occurred and the unit entered the Indicating condition again, and continued operation eventually led to further fatigue damage and the unit progressed to a Leaking condition with an external leak.

After another period of normal operation, additional leaks occurred in the cap sheet and parting sheets occurred, progressing the unit to a Leaking condition. Repairs were made and the core was returned to service with Smart Layer functionality restored.

Figure 9: Story B Smart Layer Indication Stage progression

No root cause analysis was performed, but discussions with the customer indicate they were running the reboiler at turndown conditions.

The core was repaired by excavating the cap sheet crack, welding it shut, and sealing outside layers with the cross-pass leaks and venting them to the Smart Layer.
