Technical Service Bulletin

Orca Delivery Assist Mounting Hardware ***Date:*** April 10, 2018 ***TSB-MBS-1018***

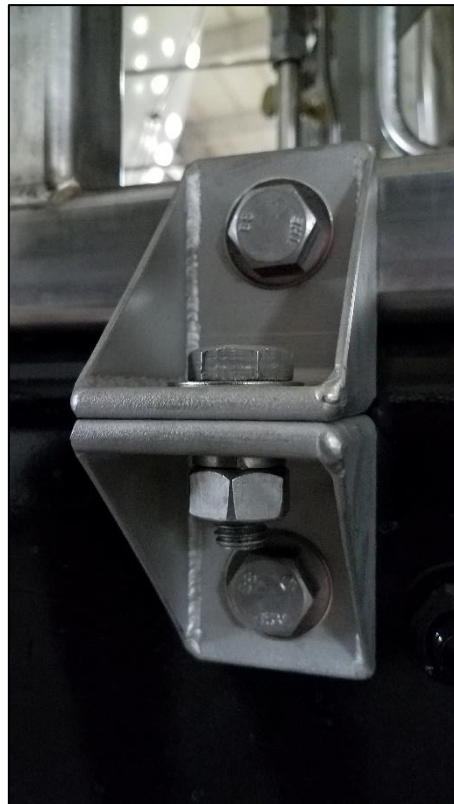
Issue: Mounting hardware becoming loose on Chart Orca delivery assist systems. Road vibration may cause fasteners to loosen over time. This leads to improperly tightened hardware and/or missing hardware. If not addressed, movement of the delivery assist tank could cause breakage in remaining mounting hardware.

Above is an image of an example of the original mounting hardware.

1. Review of all Orcas equipped with a delivery assist system. Review mounting hardware and check for tightness.
2. If mounting hardware appears to be tight and in good working order, implement a monthly inspection review of all mounting hardware.
3. If mounting hardware is found to be loose, discontinue use of Orca and replace with updated hardware kit immediately. Contact Chart for hardware kit (21261149).
4. If new / updated mounting hardware is present, it is recommended to continue the preventive maintenance and inspection noted above.
