VT-0008LR	001	10/17	JA/BBK
	Periodic Requalification of R110 HLNG Vehicle Fuel Systems

This document provides the necessary recommendations that allow recognized Technical Services to perform periodic requalification of Chart HLNG vehicle tanks according to the requirements of UNECE Regulation No. 110.

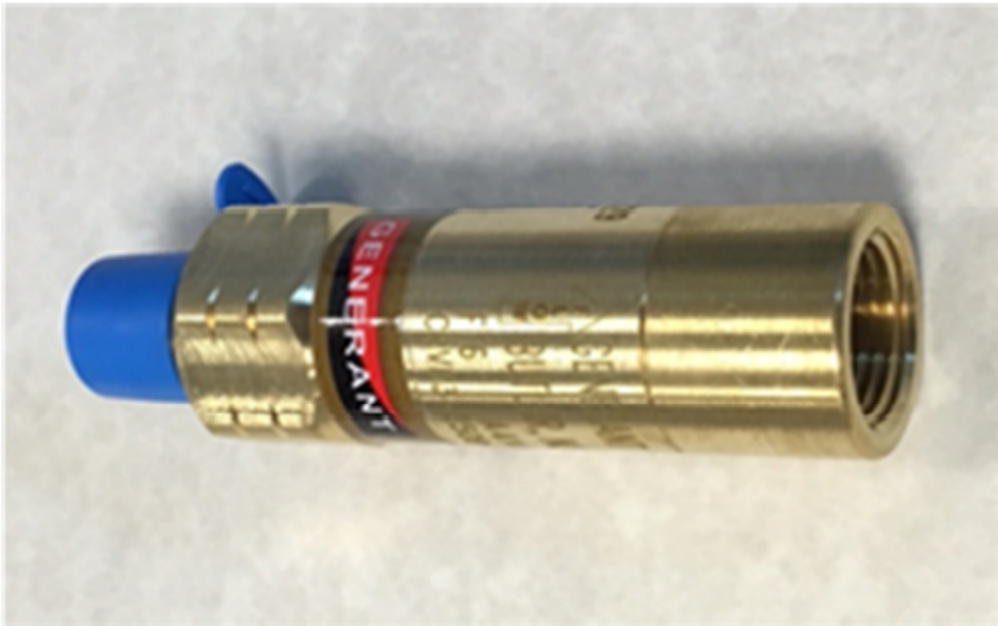
Primary relief valve 16 BAR Chart Part number 20537940
 Has hash marks on wrench flats. Also has pipe away adapter to accept pipe away elbow and tubing.

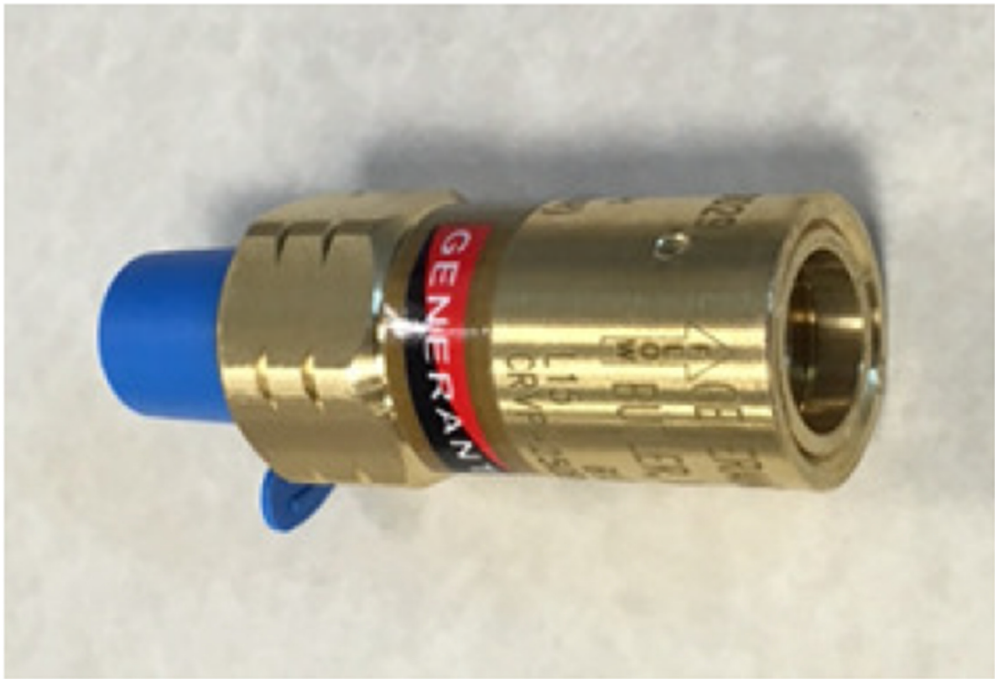
Secondary relief valve 24 BAR Chart part number 13907496
 Has hash marks in wrench flats. Does not have a pipe away adapter. Also has insert in the end to cover the threads, so it cannot be piped away.

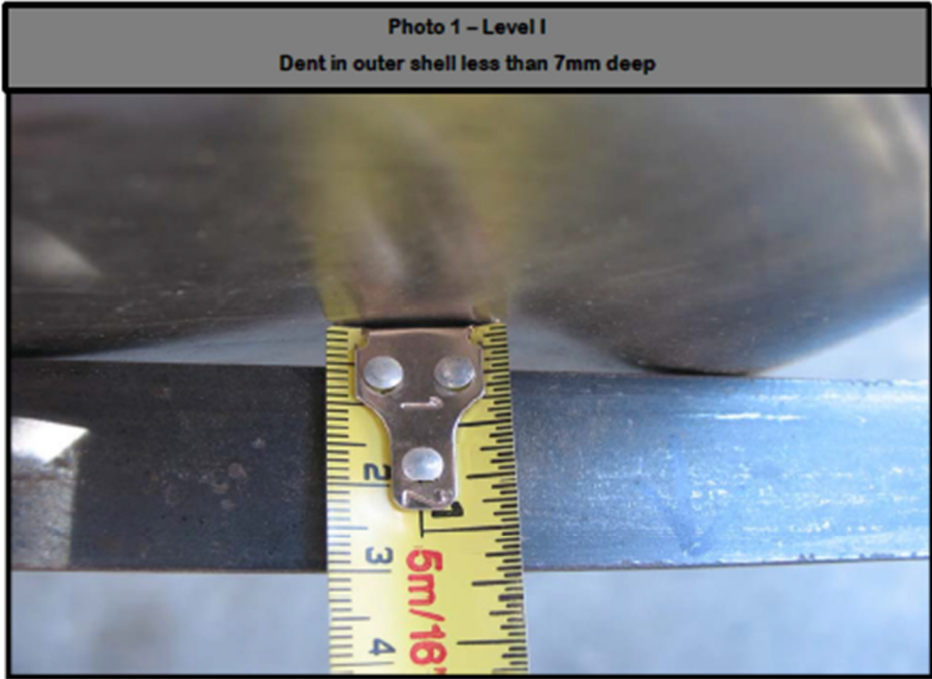
Level I damage: Category I damage is defined as minor dents or scratches that do not jeopardize the structural integrity of the tank, nor do they affect the tank performance. Photo 1 below shows Level I damage in the form of a dent in the outer shell of the tank. A straight edge is placed across the dent and the depth of the dent is measured with a tape measure or straight rule. In this case the dent is just under 7mm deep and is acceptable. If there are no signs of frost or sweating the tank can be returned to normal service. Photo 2 shows Level I damage in the form of surface scratches to the outer tank shell.

Level I damage: An inspection was performed. No further action is necessary, return the tank to service.

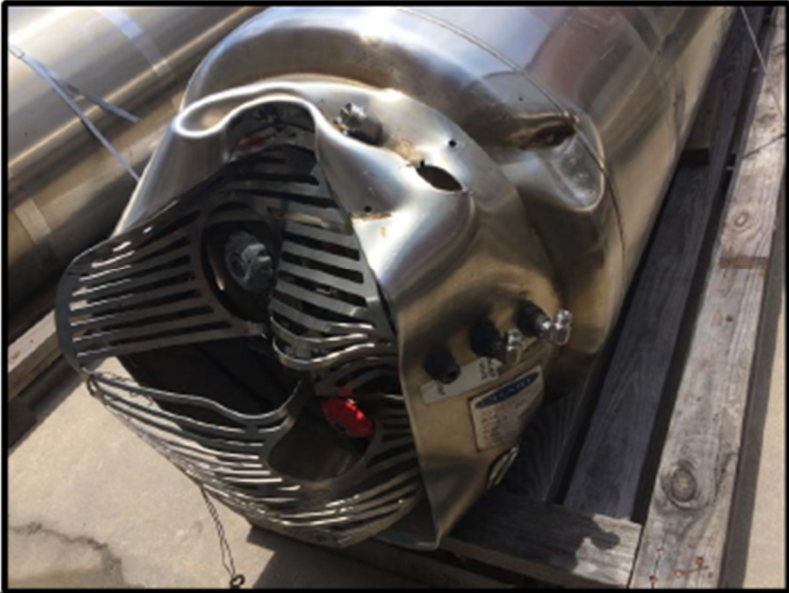
**Photo 5 – Level III
Extensive damage to shroud, front head and tank support**

Level III damage is considered as a tank that is too badly damaged to repair or return to use. In all Level III damage cases the tank needs to be immediately de-fueled if safe to do so. Then it needs to be purged, removed from service and scrapped.

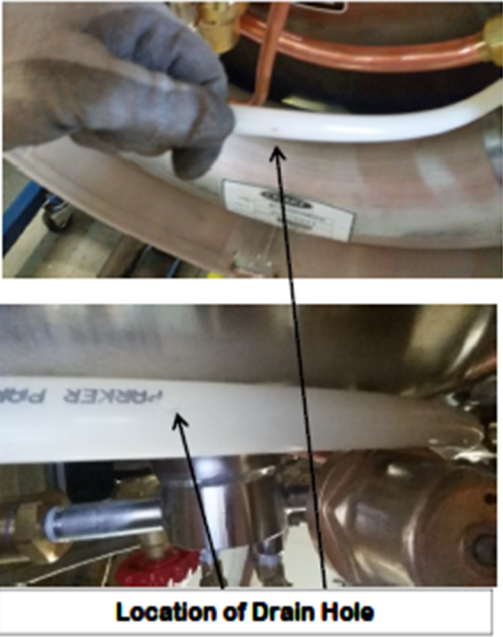
Chart LNG vehicle tanks incorporates a low point water drain hole. It is a 3mm predrilled drain hole located at the lowermost portion of the nylon tubing, it allows water and moisture to drain from the line. When the primary relief valve opens, the vast majority of gas goes out through the nylon tube and toward the vent stack outlet, however a small amount may be discharged out of the drain hole. This is a normal function of the tube.

**DO NOT PLUG OR BLOCK THE MOISTURE DRAIN HOLE!
IT IS AN INTEGRAL PART OF THE TANK DESIGN.**

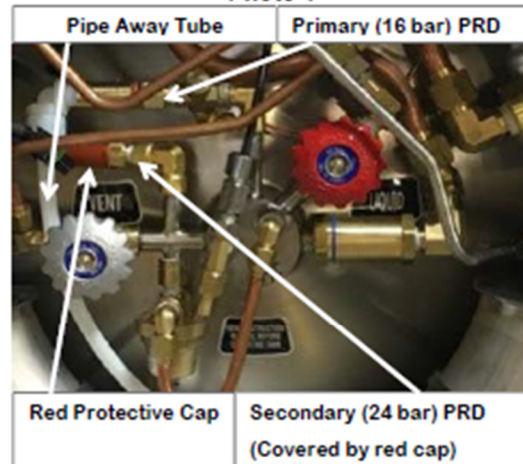
Photo 1

The red cap must be installed completely onto the secondary PRD and not show any signs of damage or cracking. The pipe away tube must be present and not visually kinked or damaged. (See photo 1)

If a tank is identified as having a missing or damaged red cap, the vehicle must be placed out of service until a follow up inspection can be performed. The follow up inspector must identify the reason for the red cap being discharged. When placing the vehicle out of service a tank pressure inspection must be performed to ensure the tank pressure is not in an over pressurized condition. If the tank is above 14 bar it must be vented down to 10.5 bar and monitored/vented daily until the inspection/repairs can be completed.
