Technical Service Bulletin

Orca Wrench Assembly

Date: February 23, 2018

TSB-PKG-1017

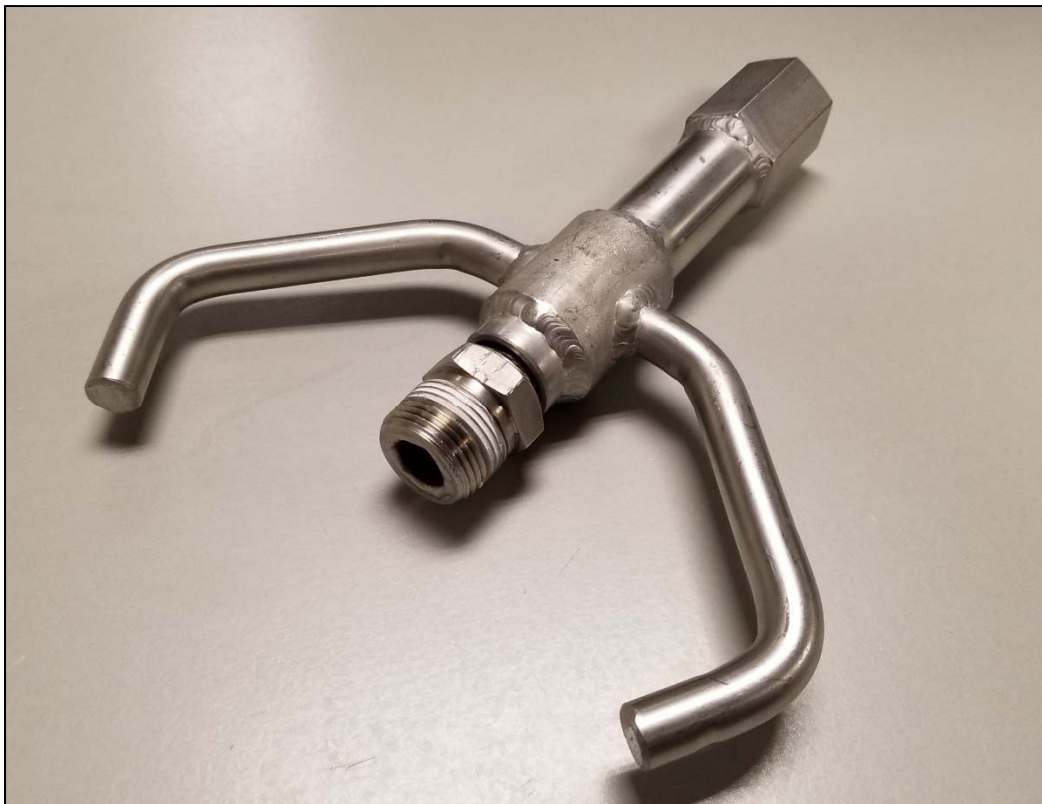
Above is an image of an example of a one model of a wrench assembly.

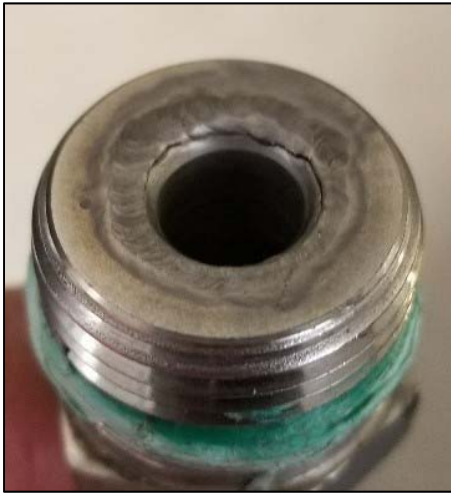
1. Review of all Orca wrench assemblies in possession. Review assemblies for noted welding pattern below and examine for hairline stress cracks or any separation of weld between the nut and tube of the assembly. Discontinue use and replace immediately if either of these welding designs appear to be present.

Chamfer in tube assembly defect

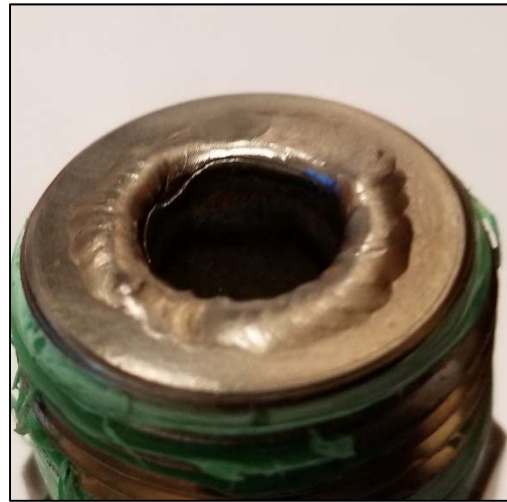
Crack in welded joint example

2. If wrench assemblies appear to be in good working order and free of stress crack, implement a 3-month inspection review of all wrench assembly for any stress cracks. If stress cracks are present discontinue use and replace immediately. At this same time interval, it is best practice to clean the flare end threads with bottoming tap to clear any brass debris from use.
3. If wrench assembly is difficult to turn and flare connection will not seal, replace with new.
4. If new / improved weld is present, it is recommended to continue the preventive maintenance and inspection noted above.

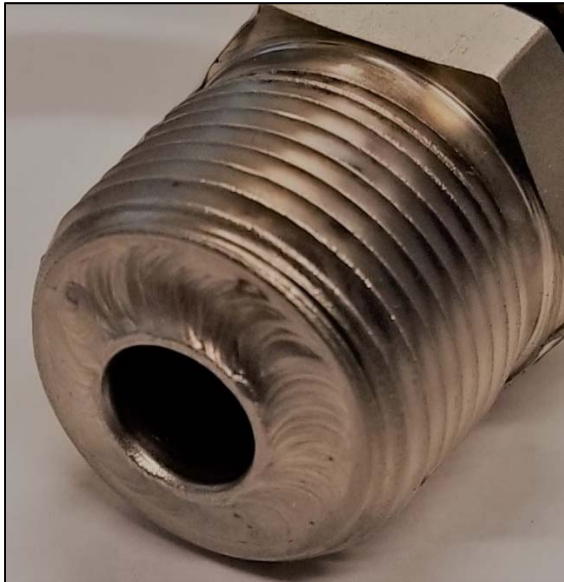
New welded joint

Any shipments after February 9th, 2018 will have the new weld joint.

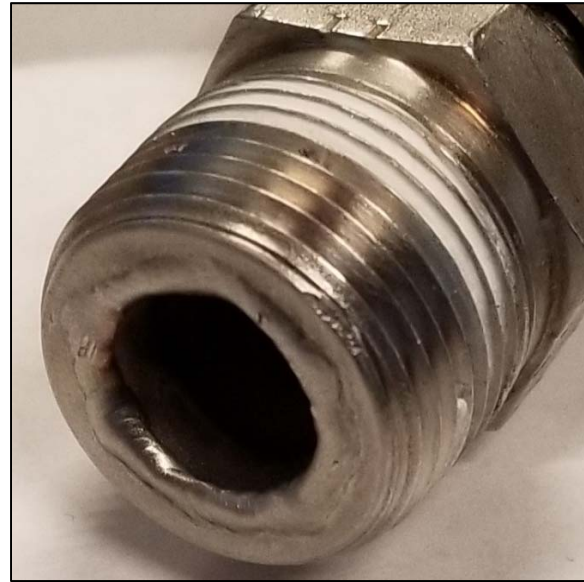
Old welded joint
