## Piston Redesign Extends Life of Cylinder Bores

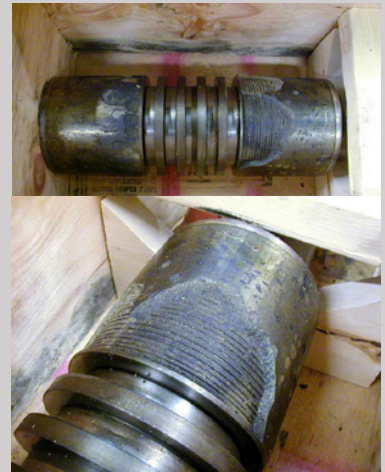
Pistons and bronze riders were wearing the cylinder bores over time and the customer would have to have the cylinder re-sleeved plus have the pistons sent out to have the bronze riders machined out and new bronze riders sprayed on.

Customer's original single piece piston, showing damage to the sprayed on bronze rider bands

During the 2012 outage CPI, part of the Howden group, was provided a sample of the customer's piston and we recorded the weight, dimensions and operating parameters of the unit. Engineering then designed a new three piece aluminium / steel piston with CPI 315 riders and piston rings to fit their dimensional and operating parameters. The customer approved the design and installed CPI's piston for trial.

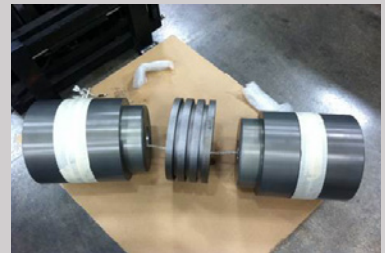
CPI's solution, an engineered 3-piece piston, to carry CPI 315 piston and rider rings

The initial trial of three months was sufficient for the customer to approve the new CPI piston design and take the decision to convert a further six cylinders in 2013, followed by six more in 2014. They then converted all of their 24 cylinders over to the new CPI piston design over the following two years.
