CPI supplies redesigned compressor cylinder and valves to eliminate cracking at fertilizer manufacturer

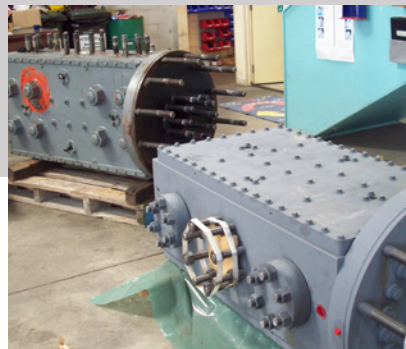
The new cylinder (near) featured thicker and stronger valve port walls, but that required redesigned valves to fit the smaller openings.

The first step in addressing the problem was to redesign and install a new cylinder for the third stage compression. In consultation with our alliance partner a redesigned cylinder was manufactured, featuring reduced valve pocket diameter to increase strength and eliminate cracking.

The reduced valve pocket diameter in turn required redesigned compressor valves to fit the smaller pockets. CPI custom-designed, manufactured and installed a cylinder set of new inlet and discharge radiused disc (RD) valves for both the head and crank ends.

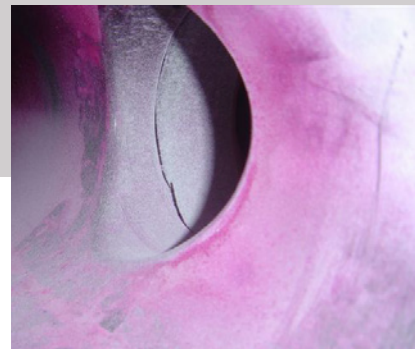
The original valve port walls were not thick enough to withstand the pressure created by the compressor.

The customer contacted CPI, part of the Howden group, to help diagnose and solve the problem. An inspection revealed that the syn-gas was leaking from cracks in the valve pockets. CPI determined that an inherent weakness in the cylinder design caused the cracks to occur.

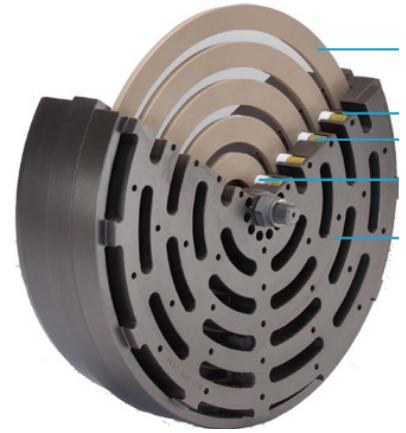
Suitable for use in a wide range of applications, including oil, gas, petrochemical, air separation and sour gas, CPI's radiused disc valves are designed to operate under discharge temperatures up to 200°C/390°F and pressures in excess of 400 bar/6,000 psi. All CPI radiused disc valves are custom designed in close consultation with the customer to meet the specific operating and dimensional needs of the compressor.

Radiused disc valve features and benefits:

- streamlined flow enabling free passage of entrained solids and liquids reducing risk of damage and improving reliability
- flow increase due to good sealing
- conformability with seat - under a wide range of operating conditions
- durable thermoplastic discs with no seat damage or wear
- simple internal design - easy to service
- soft-tempered seat and guard -sour gas (H2S) service (NACE)
- suitable for both lubricated and non-lubricated applications
- increased efficiency and savings on power consumption
- less back-flow and often lower process gas temperatures

Further, the radiused discs absorbed broken garter springs from a failed gas packing and continued operating without any loss in performance.
