Redesigned Valve Cage & Cover Eliminate Multiple Gas Leaks

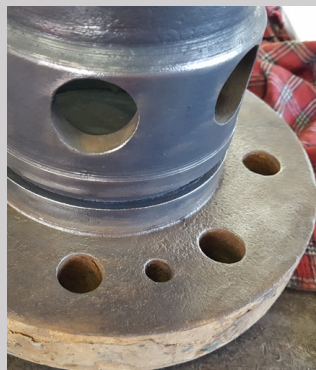
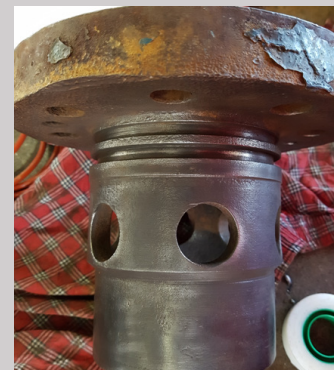
During the last few years the customers' compressors have suffered many leaks through the valves' cages/covers. When the plant operators approached the compressors the gas detector alarms would activate. The compressors were shut down to work on the units safely.

The elements were leaking due to the walls of the valve ports. The components showed a lot of corrosion and superficial pitting. A new valve cover / cage design was required. The addition of new O-rings and gaskets that would improve the seal against the valve port walls and surface of the actuator groove.

CPI, part of the Howden Group, designed and manufactured a new valve cage and valve cover that improved both gas sealing and maintenance operations and allowed the installation of new pneumatic actuators. The new valve cover includes machined grooves to house O-Rings and a back-up gasket, improving the gas sealing capability of the complete assembly once installed
