Piston Redesign Extends Life of Cylinder Bores

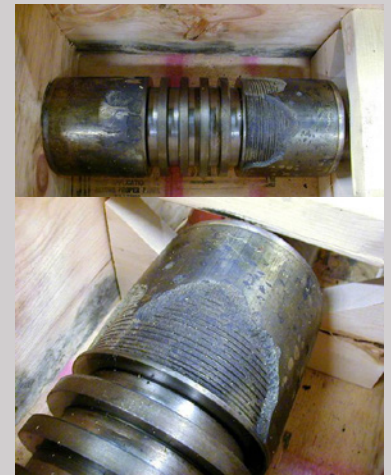
The compressor unit was running an original one-piece solid piston with solid bronze dovetailed rider bands and laminate piston rings. Pistons and bronze riders were wearing the cylinder bores over time and the customer would have to have the cylinder re-sleeved plus have the pistons sent out to have the bronze riders machined out and new bronze riders sprayed on. This procedure was very costly and time consuming for the customer.

Customers original single piece piston, showing damage to the sprayed on bronze rider bands

During the 2012 outage CPI, part of the Howden group, was provided a sample of the customer's piston and we recorded the weight, dimensions and operating parameters of the unit. Engineering then designed a new three piece aluminium / steel piston with CPI 315 riders and piston rings to fit their dimensional and operating parameters. The customer approved the design and installed CPI's piston for trial.

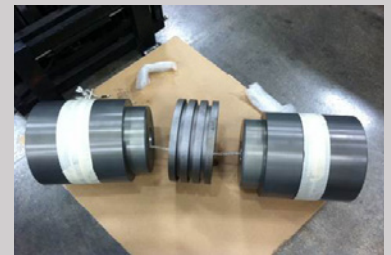
CPI's solution, an engineered 3-piece piston, to carry CPI 315 piston and rider rings

The initial trial of three months was sufficient for the customer to approve the new CPI piston design and take the decision to convert a further six cylinders in 2013, followed by six more in 2014. They then converted all of their 24 cylinders over to the new CPI piston design over the following two years.
