Restoring Compressor Reliability Through Rapid Cylinder Rehabilitation in Ivory Coast

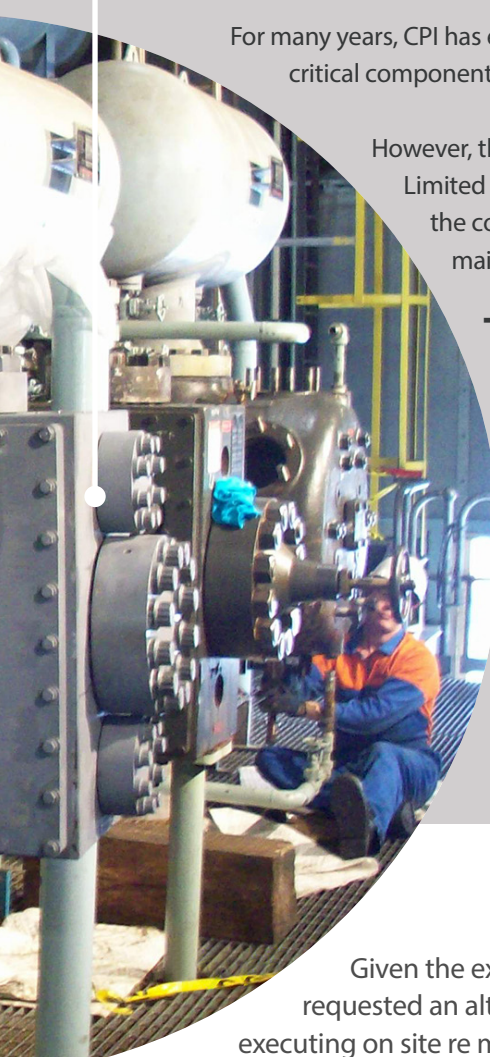
In December 2025, a lubrication failure resulted in rapid degradation of the Packings and Piston/Rider Rings. This failure escalated quickly, causing direct contact between the piston and the first stage liner. The liner suffered significant damage, including deep scratches and severe marking across the active surface area, requiring immediate technical intervention.

Machining operations eliminated deep scoring and surface defects on the liner's active area, restoring its functional integrity.

Given the excessively long lead times for supplying a new cylinder liner (shirt), the customer requested an alternative solution to minimise downtime. CPI responded by proposing and executing on site re machining of the existing liner, complemented by the supply of two new sets of Piston/Rider Rings adapted to the restored cylinder diameter.
