<b>ES-24.30</b>	<p>HUDSON PRODUCTS CORPORATION <i>Fan Engineering Standards</i></p> <p><b>Title: Field Inspection Guidelines Hudson Tuf-Lite® (Black), Tuf-Lite II® (Blue) And Tuf-Lite III® (Green) Blades</b></p>	Page 1 of 6
-----------------	---	-------------

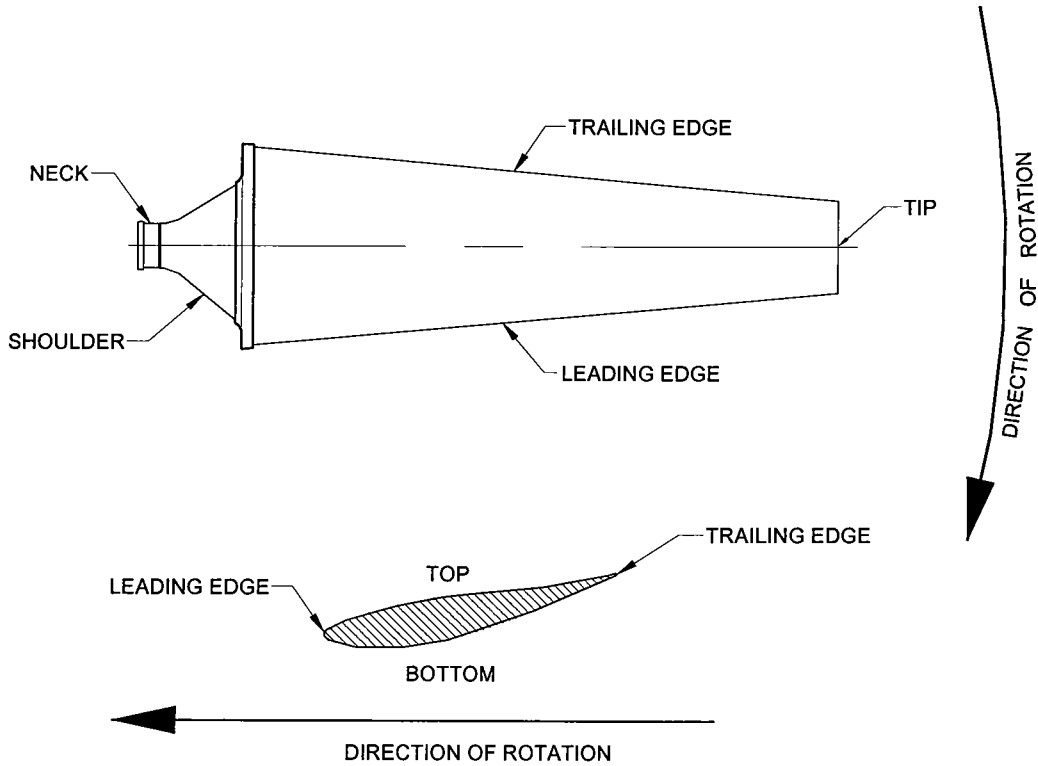
- 1.1 The **leading edge** is the rounded portion of the blade.
- 1.2 The **trailing edge** is the thin section of the blade.
- 1.3 The **neck** is the cylindrical area under the blade clamps.
- 1.4 The **shoulders** are the tapered transition area from the neck to the widest part of the blade.
