Turboexpander repair and maintenance for sustained performance and profitability

L. E. RODRÍGUEZ and R. HOCH, L.A. Turbine, Los Angeles, California

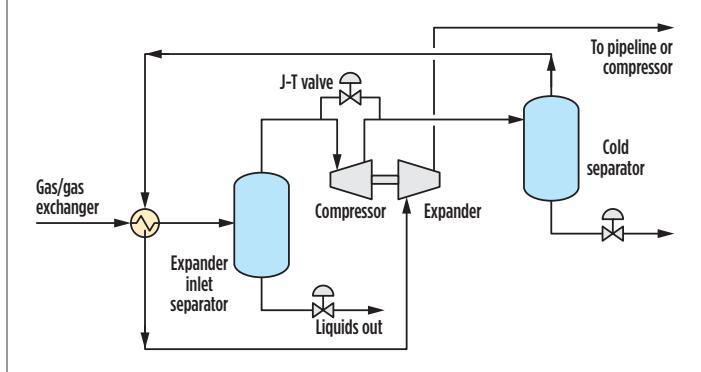
FIG. 1. Typical natural gas liquefaction process.

What is a turboexpander? A turboexpander is a rotating machine equipped with a radial inflow expansion turbine and a loading or breaking device, such as a centrifugal compressor stage, a generator or an oil brake. Unlike a power generation or mechanical drive turbine, which works mainly to generate power, an expander's main purpose is to increase the efficiency of a gas expansion process. FIG. 1 provides a schematic of a typical turbo-expander operating in a gas liquification process.¹

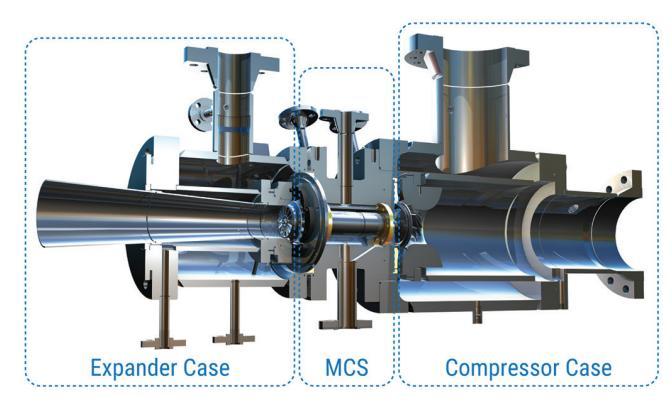
FIG. 2. Turboexpander cross-section. Image courtesy of L.A. Turbine.

What are the components of a turboexpander? A typical turboexpander comprises three main sections—namely, the compressor case, the expander case and the mechanical center section (FIG. 2).

Turboexpander cases are usually radially split and grouped in three distinct parts. The expander casing is usually stainless steel, due to the low-temperature gas it contains. In many designs, it houses the inlet guide assembly. The compressor casing is usually made of carbon steel. It forms the diffuser part of the compressor stage, as well as the collector or volute, depending on the design.

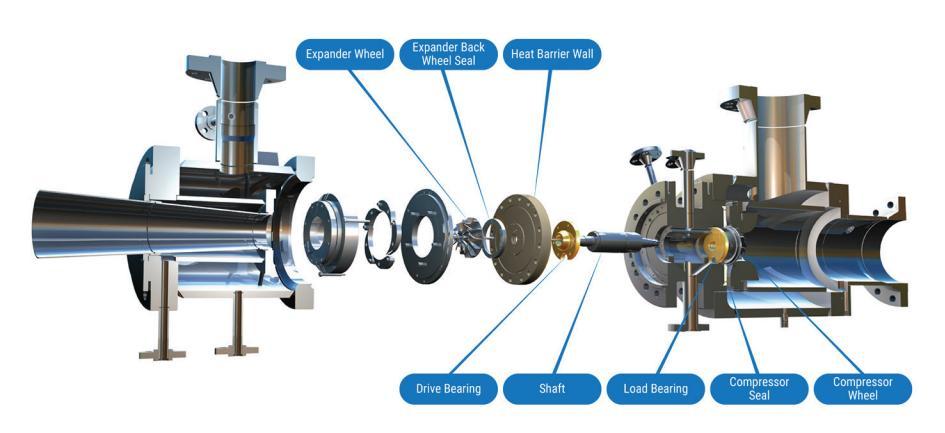
FIG. 3. Mechanical center section detail. Image courtesy of L.A. Turbine.

FIG. 3 focuses on the mechanical center section (MCS), which is the heart of the machine. The bearing housing is usually carbon

steel and contains almost the entire machine, from the expander wheel to the compressor wheel. It includes the rotor, bearings and seals. The following is an overview of the key components of the MCS and their functions and main design features.

Rotor. The rotating element is comprised of a shaft (often made from stainless steel) with a radial inflow turbine wheel attached on one end and the loading device, which in **FIG. 3** is a centrifugal compressor wheel, but it could be a generator or a dyno.

Bearings. These components support the weight of the rotor, as well as overcome the axial force (thrust) originated by the difference in pressures between the front and back of each wheel. Ideally, the thrust in one wheel would be equal and opposite to that of the opposite wheel, but this is rarely the case. In most cases, turboexpanders are equipped with either hydrodynamic oil bearings (FIG. 3) or active magnetic bearings (AMBs) (FIG. 5).

On the compressor side of the machine, the stationary seal element (called a compressor seal, see FIG. 3) can be made of different materials, depending on the application, but an aluminum alloy is common. From a repair perspective, a typical finding is that the seal areas—both on the heat barrier wall and the compressor seal—have experienced some degree of wear due to rubs. Rubs are not uncommon and are related to transient excursions of rotor lateral vibrations, usually during startup. They can be repaired by boring out the damaged section(s), installing a blank insert of a matching material and re-machining the seal features to specification.

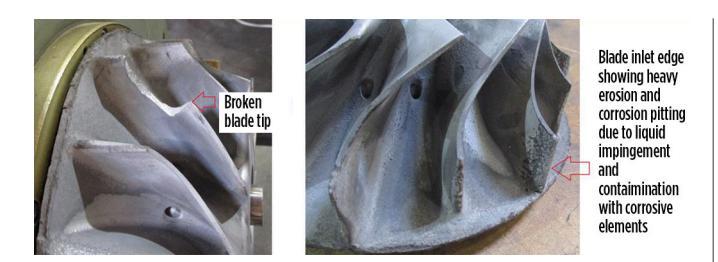
FIG. 4. Wheel with extensive corrosion damage.

FIG. 4 shows an example of finding No. 6 in which replacing the wheel was necessary. Here, an expander wheel blade was cracked during operation. A visual examination shows heavy corrosion damage throughout. A metallographic evaluation

shows that the crack likely occurred due to a type of mechanical fatigue that is precipitated by a corrosive element (known as stress corrosion cracking). In such an extreme case, some measures can be taken from a repair or redesign perspective to ameliorate the problem. Ultimately, however, resolution of the contamination problem at the plant process level is inescapable.

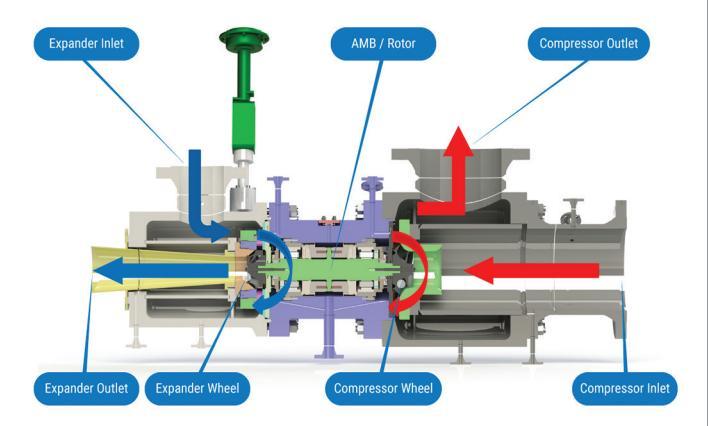
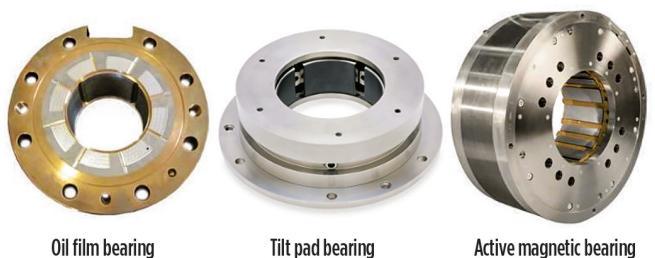
Oil film bearing

Active magnetic bearing

FIG. 6. Bearing options. Images (center and right) courtesy of Waukesha Bearings

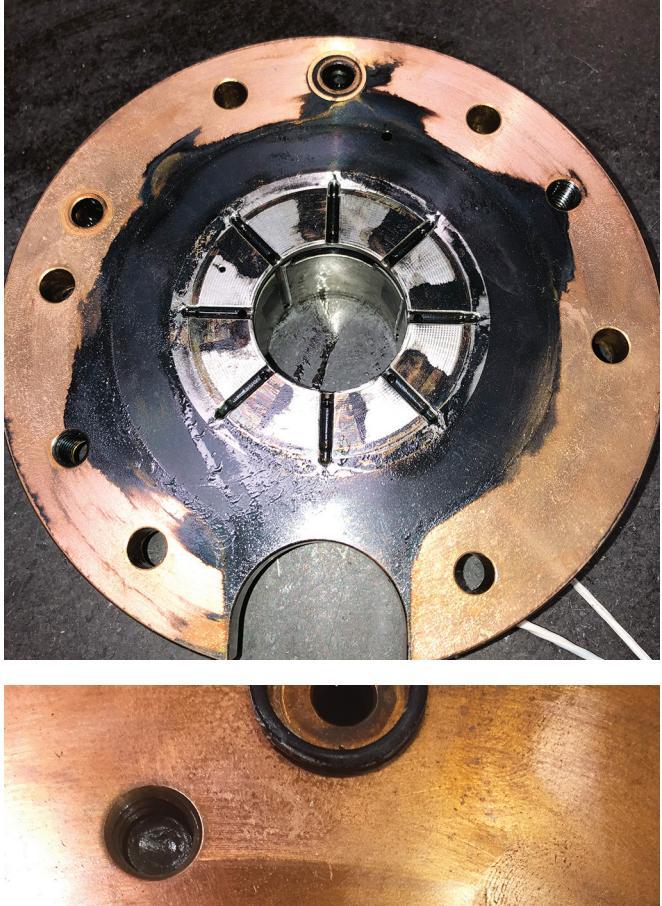
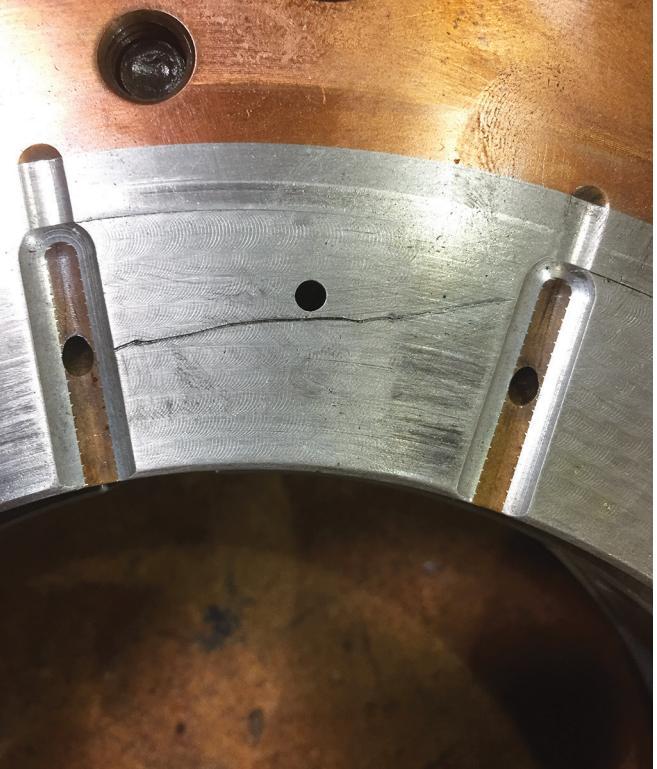
FIG. 7. Oil bearing damage.

Sometimes a failure analysis is warranted. For example, **FIG. 7** shows a case in which oil contamination led to exceedingly high oil operating temperatures evidenced by bearings covered in black residue (upper image). In another instance, a bearing shows damage to the thrust face caused by electrical sparking during operation (lower image).

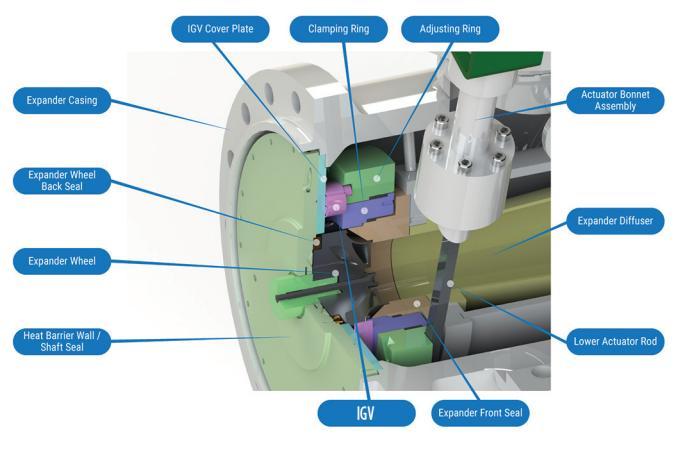
FIG. 8. Variable inlet guide vane assembly. Image courtesy of L.A. Turbine.

expander gas to enter the rotating wheel. They also function like a valve, by closing to pinch the flowrate. OEMs differ widely in their chosen designs for IGVs. Some choose to have four or five vanes with simple adjustment mechanisms. Others opt for a larger number of vanes with complex linkage mechanisms.

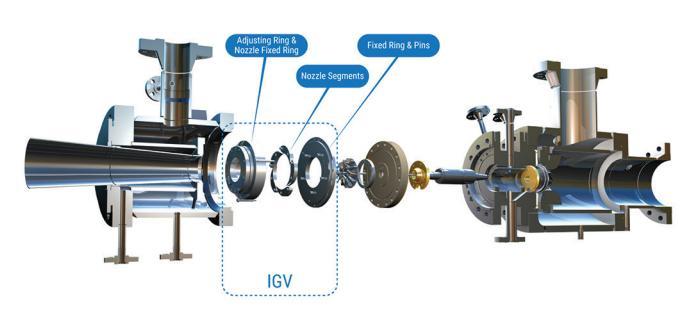
FIG. 9. Inlet guide vane example. Image courtesy of L.A. Turbine.
