MVE Beverage Systems

Technical Service Bulletin

Component Change

Sure-Fill™ Assembly

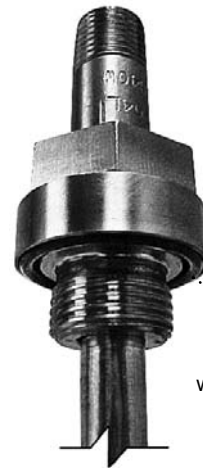
Sure-Fill plug tube assembly with retro-fit o-ring seal design.

Instances of leakage have been discovered at the Sure-Fill tube plug (seal) on a few vessels that were produced between January and September 2002 . Chart has identified and corrected the cause of this occasional condition. Additionally, Chart has developed a retrofit Sure-Fill tube that will correct such leakage on vessels in service that were produced within that time frame and have a leak at the Sure-Fill plug seal. The retro-fit Sure-Fill tube assemblies are specific for vessels experiencing Sure-Fill plug seal leakage and are available from Chart without charge. **Note:** Vessels that contain liquid CO₂ and do not have a leak at the Sure-Fill plug seal are not subject to the condition and do not require the retro-fit assembly.

Chart’s part number for a 3/4 - 16 UNF retro-fit Sure-Fill tube assembly (for a Carbo-Charger or Carbo-Mizer) is 11764313. The part number for a 7/8 - 14 UNF retro-fit Sure-Fill tube assembly (for a Carbo-Max 600) is 11764330. When ordering a retro-fit Sure fill tube assembly please provide the model and serial number of the affected vessel. Chart will arrange replacement and immediate shipment of the assembly at no charge. This parts replacement program is in effect for orders placed by March 31, 2003. **Caution: Before removing a Sure-Fill tube assembly from a CO₂ storage vessel be sure that the vessel is empty and has no internal pressure!**
