## Technical Service Bulletin

TSB-Y10-002

Flush Mount CO<sub>2</sub> Fill Box Modification

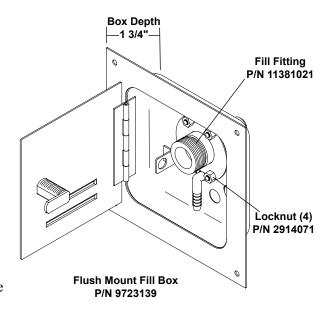
The stainless steel fill box is a major component of a stationary  $CO_2$  fill circuit. It provides access to the  $CO_2$  fill fitting while providing the port for safely venting excess  $CO_2$  gas outdoors.

The brass fill fitting inside the fill box will become worn or may be damaged over time after repeated  $CO_2$  delivery connections. It will eventually need to be replaced. To enable its easy replacement, the fill fitting (P/N 11381021) is simply fastened onto four studs in the fill box using 1/4"-20 stainless steel locknuts (P/N 2914071.) The box does not need to be removed to replace the fill fitting. In fill boxes manufactured before this modification, replacement of the fill fitting (P/N 11014459) requires removal of a mounting plate inside the box, and removal and replacement of six mounting rivets.

**Note:** When replacing a fill fitting in the modified fill box, the lock nuts should be tightened to a torque not to exceed 100 inch-pounds to avoid breaking the mounting studs.

This product modification is intended to simplify fill box maintenance. It was made standard after prototype fill boxes were thoroughly and successfully evaluated in field service. The part number (9723139) for the flush mount fill box has not changed.
