TR² Success on the 2nd Stage of an Ingersoll Rand Ethylene Primary Compressor

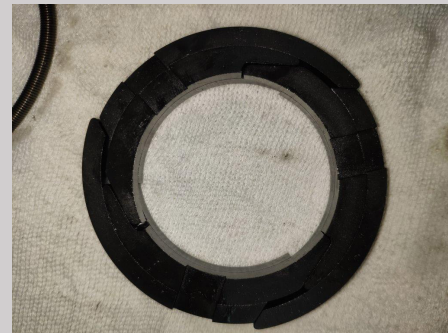
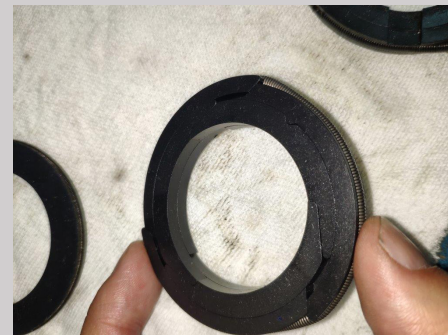
After opening the packing case the customer was very surprised to witness the condition of the rings. The rings were not worn out (see pictures), they were "like new".

CPI Emissionguard TR² packing ring after use

After some discussions with the customer, he decided to replace the existing rings with CPI's EMISSIONGUARD TR² packing rings, but only on the 2nd stage of the compressor.

The TR² rings were working for more than 22,000h without any problems. Vent leakage reduced considerably.
