Successfully addressing kiln ID fan erosion issues

Lafarge Cement, Egypt

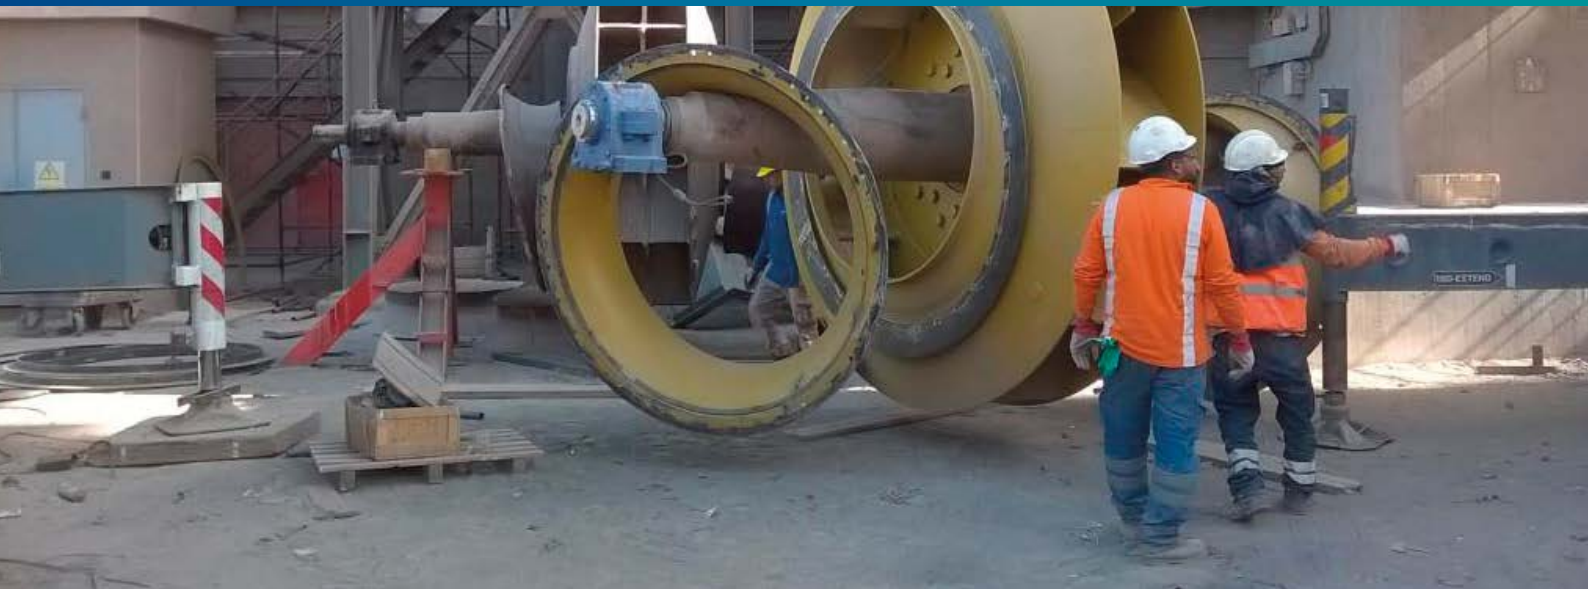
Several years ago, erosion appeared on the kiln ID fan of line 5 at Lafarge Cement, Egypt El Sokhna plant. This facility operates 5 integrated cement production lines at El Kattamia, Suez, Egypt which has a total cement production capacity of 10,6 mtpy. Line 5 kiln ID fan has been operating since 1996 without any problem of erosion. However, the dust laden that was flowing through this fan had increased due to various parameters. In these new operating conditions, the existing kiln ID fan could not run without troubles. As Lafarge Cement was holding several spare rotors, the plant maintenance team carried-out repairs of these rotors by adding new wear plates on the airfoil design blades.

The repairs were carried out by local companies. After they were repaired, the rotors could withstand the erosion but still required repairing on a regular basis. After some time, all the rotors were severely damaged and Lafarge Cement considered retrofitting this fan. The team's objective was to get a new rotor that would use a more adapted design to the current dust laden without compromising on the fan performance. Lafarge Cement asked Howden to conduct this line 5 kiln ID fan retrofit job at El Soukhna plant. With its numerous brands and over 5000 cement process fans operating around the world, Howden has unrivalled experience in retrofitting cement fans throughout the world.

The Howden and Lafarge Cement teams collaborated for the full analysis of the situation. Howden retrofit experts carefully studied the kiln ID fan's operating conditions and its design.

The result of this study coupled with a dust chemical analysis were used for the selection of a new fan design and hard-facing material to improve the lifetime of the rotor.

Howden experts selected a fan design which provides high efficiencies and exhibits low erosion levels.

It can achieve almost the same shaft absorbed power than the previous design. The new Howden fan is using backward curved blades as apposed to the airfoil design that was on the previous fan. **See table 1 for details.**
