Air Preheater Seal System Retrofit

Almeria Thermal Power Plant, Spain

Immediate air preheater leakage reduction of over 20% giving higher performance and lower operating costs

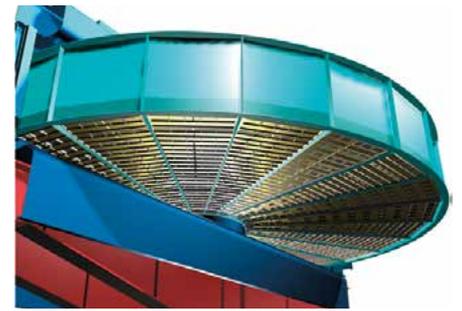
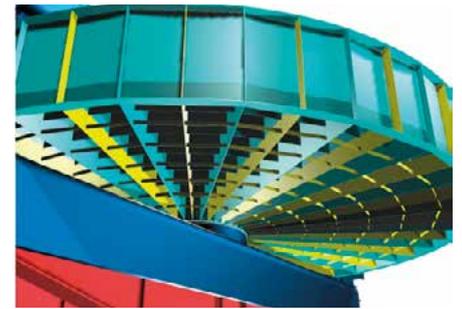
Figure 1: Double sealing by increasing the number of radial walls

The fixed plates require no actuation mechanism and the increased hot end seal gaps are compensated for by an increased number of radial walls so that there are two radial seals forming a labyrinth under the sector plate at all times.

Double sealing can usually be achieved by increasing the number of radial walls (Fig. 1) or by widening the sector plate (Fig. 2). The result in both cases is that there are two or more radial seals under the sector plate at all times and the seal leakage is reduced by a factor of $1/\sqrt{2}$.

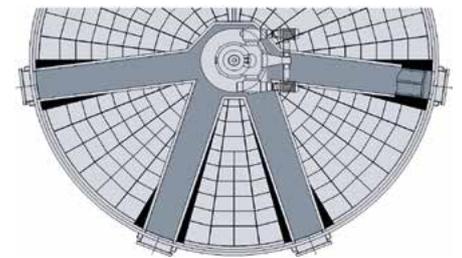
Figure 2: Double sealing by enlarging the sector plate

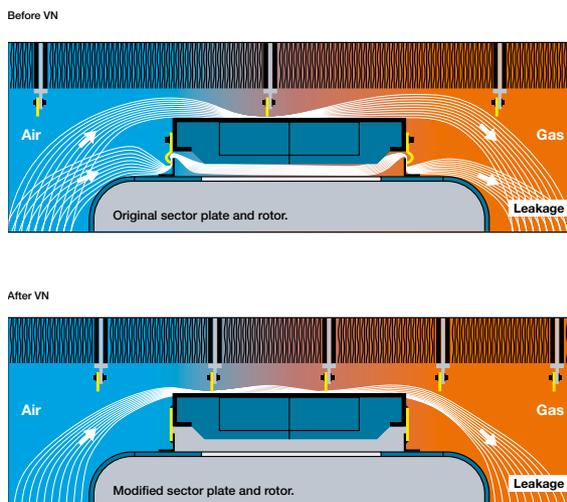
Figure 3: Elimination of leaks between sector plate and support beam.

By eliminating the need for moving parts, the fixed sector plate offers a far more reliable long-term control of leakage (Fig. 3). Thermal capping of the rotor is accommodated by the parabolic design of the bottom sector plate, which offers maximum adaptability to the radial seals (Fig. 4).

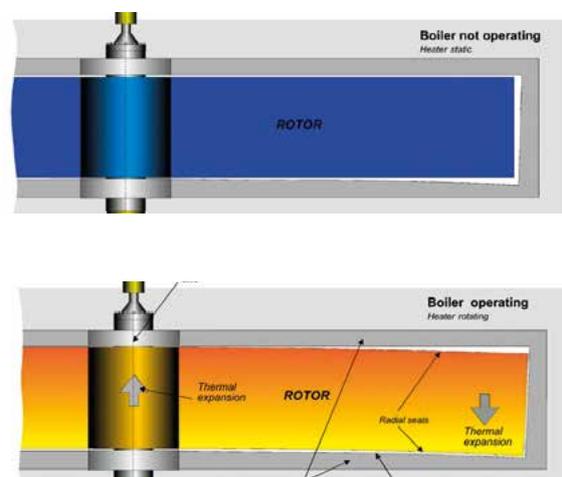
Figure 4: Elimination of leaks between sector plate and support beam.
