## *Technical Service Bulletin*

***KWG Generator Shroud***

***TSB-MBS-1042***

***Subject:*** KWG generator fan shroud drain hole addition.

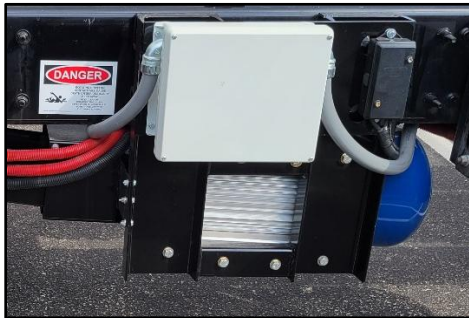
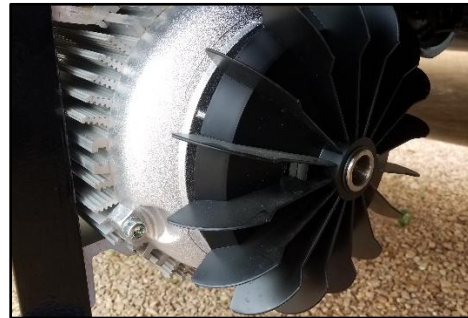
***Description:*** Water and/or road debris may accumulate in the bottom of the generator fan shroud. Colder temperatures could cause this pooled media to freeze. Cooling fan blades may fracture or break off when the generator is engaged and contacts the frozen media. Replacement cooling fan PN 22033435.

***Resolution:*** Add drain hole to the generator fan shroud. **NOTE:** Use caution as to not damage the cooling fan if procedure is performed to undamaged generator fan.
